Proposed Eagle Creek Housing Development on RE 47, 187 and 188 of Farm 220 Vyf Brakke Fontein, Mossel Bay, Western Cape.

Aquatic Biodiversity Assessment.

Prepared For: PW Steinberg
Author: Dr. J.M. Dabrowski
Confluent Environmental Pty (Ltd)
7 St. Johns Street,
Dormehls Drift,
George, 6529
SACNASP: Pr. Sci. Nat. (Water Resources – 114084)
Date: 9 October 2024
Version: Draft Final

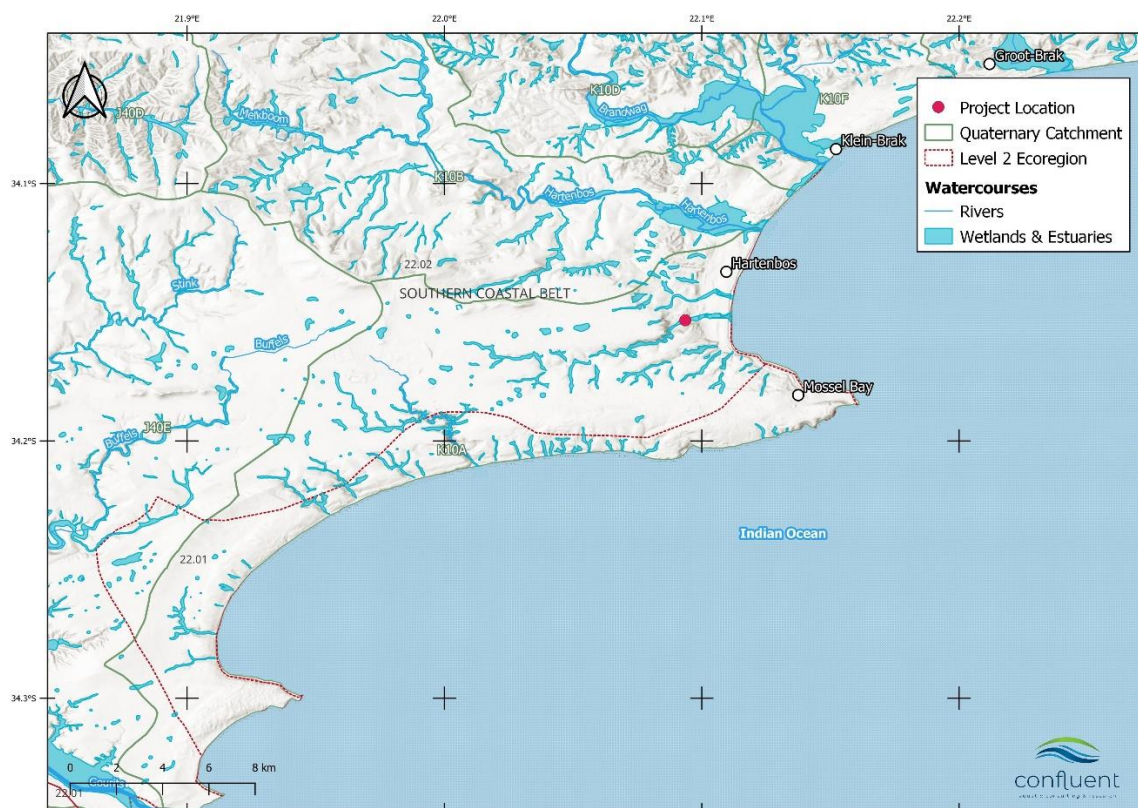
Figure 1: Map illustrating watercourses in relation to the development footprint.

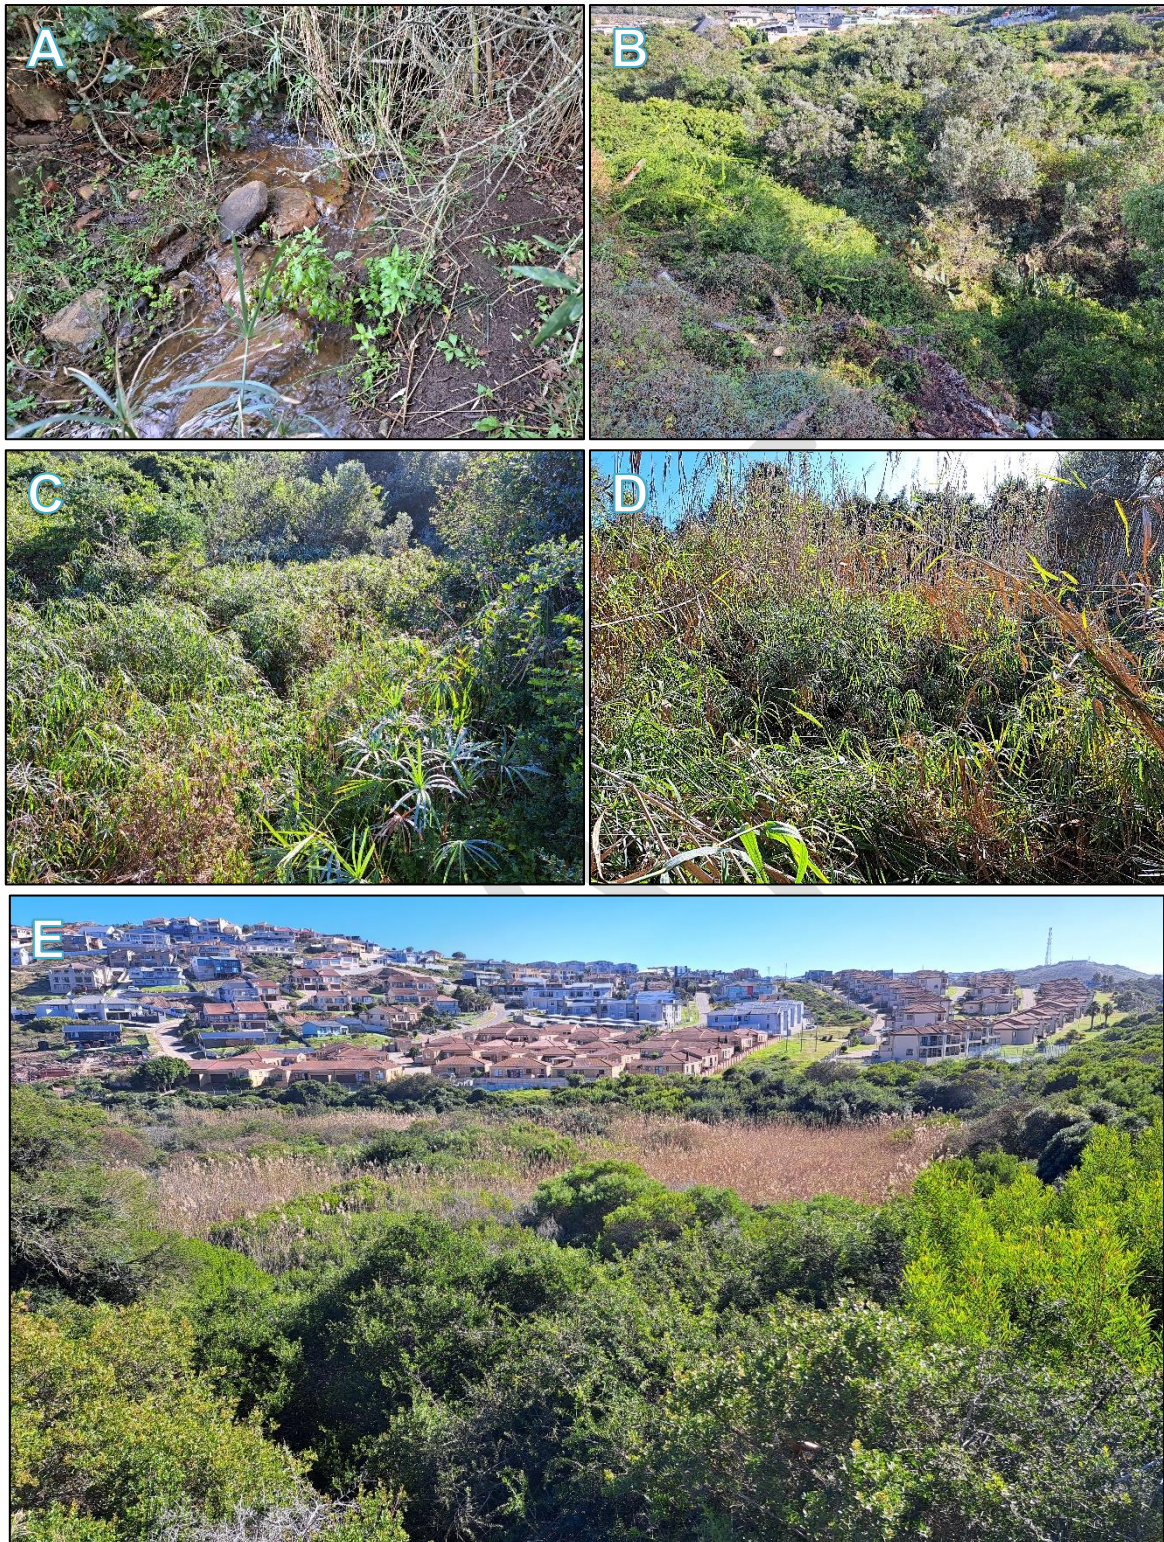
Figure 5: Photographs illustrating the narrow active channel of the river (A); steep embankment and riparian thicket vegetation along the valley bottom (B); a patch of *Cyperus textilis* in the wetland (C); patch of *Phragmites australis* in the wetland (D); and a view of the wetland as it broadens towards the N2 showing *P. australis* reed-bed.

macro-channel). The upper reach of the watercourse immediately below the dam is consistent with a narrow non-perennial river (stream), fringed by a relatively wide riparian zone consisting of thicket species, namely *Olea exasperate*, *Carissa bispinosa* and *Searsia spp.* (Figure 6). There is no wetland vegetation on this embankment and vegetation is characterised by a mixture of indigenous and invasive terrestrial shrubs and trees (Figure 5).

As the channel approaches the N2 highway, the gradient of the southern embankment becomes more gentle, and the river grades into a channelled-valley bottom wetland (Figure 6). The active channel widens and is bordered by wetland habitat, characterised by dense reed beds consisting of *Cyperus textilis*, *Arundo donnx* and *Phragmites australis*. Analysis of historical imagery indicates that the wetland area immediately south of the active channel was historically cultivated (Figure 7) and at various times in the past was crossed by various road crossings. Construction of the N2 highway resulted in infilling across the watercourse, causing impedance of higher flows, and increased inundation and saturation of the banks adjacent to the channel – enhancing wetland habitat. It also appears as if the eastern most extent of the wetland (where it widens noticeably against the N2 highway) was associated with an area of disturbance (possibly an excavation), which allowed water to extend beyond its natural course (Figure 8). The delineated extent of the riparian zone and wetland is much narrower than mapped by CSIR (2018) and is mapped in Figure 6. There are other indicators of wetland vegetation (reed beds of *A. Donnx*) outside of the delineated area indicated in Figure 6, but these are all associated with stormwater outlets that discharge stormwater from the main access road, overland towards the direction of the wetland and are not considered as natural wetland areas.

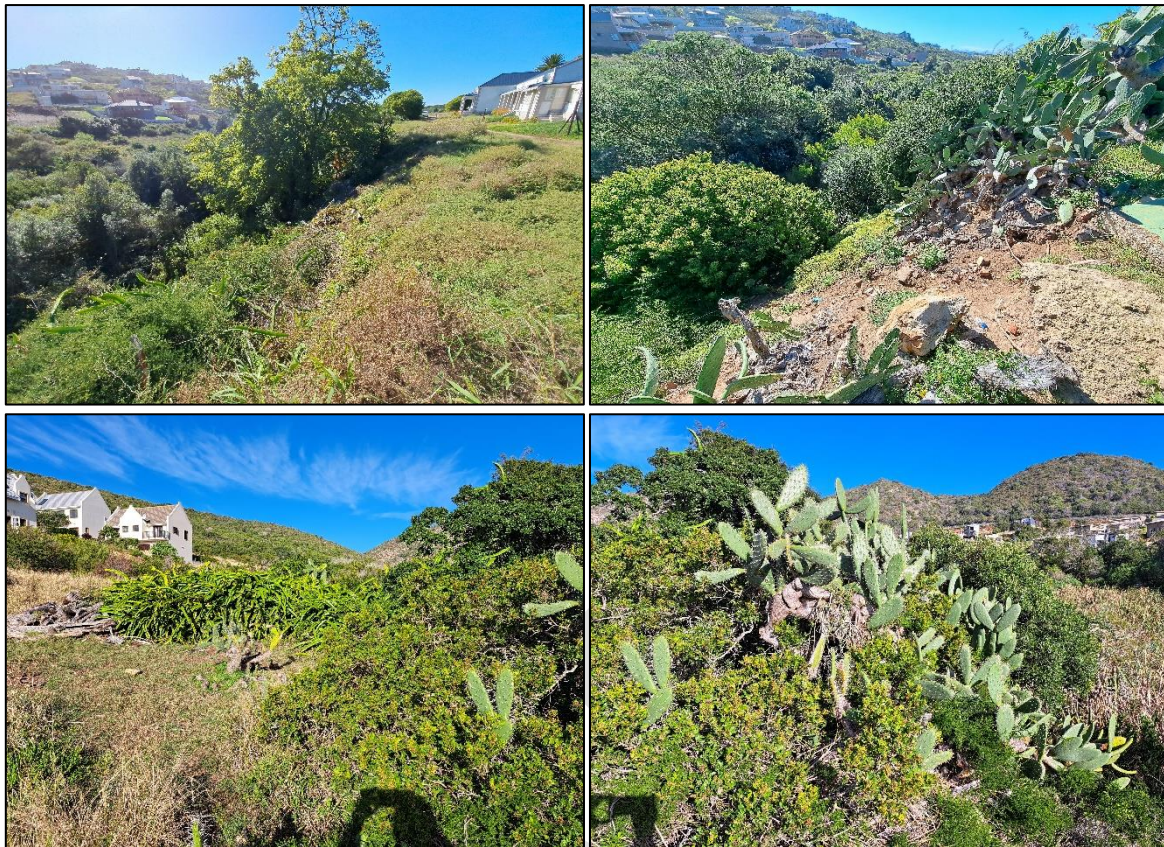
Figure 9: Photographs of the site showing the steep embankment and invasion by *Hylocereus undatus* and *Opuntia engelmannii*.

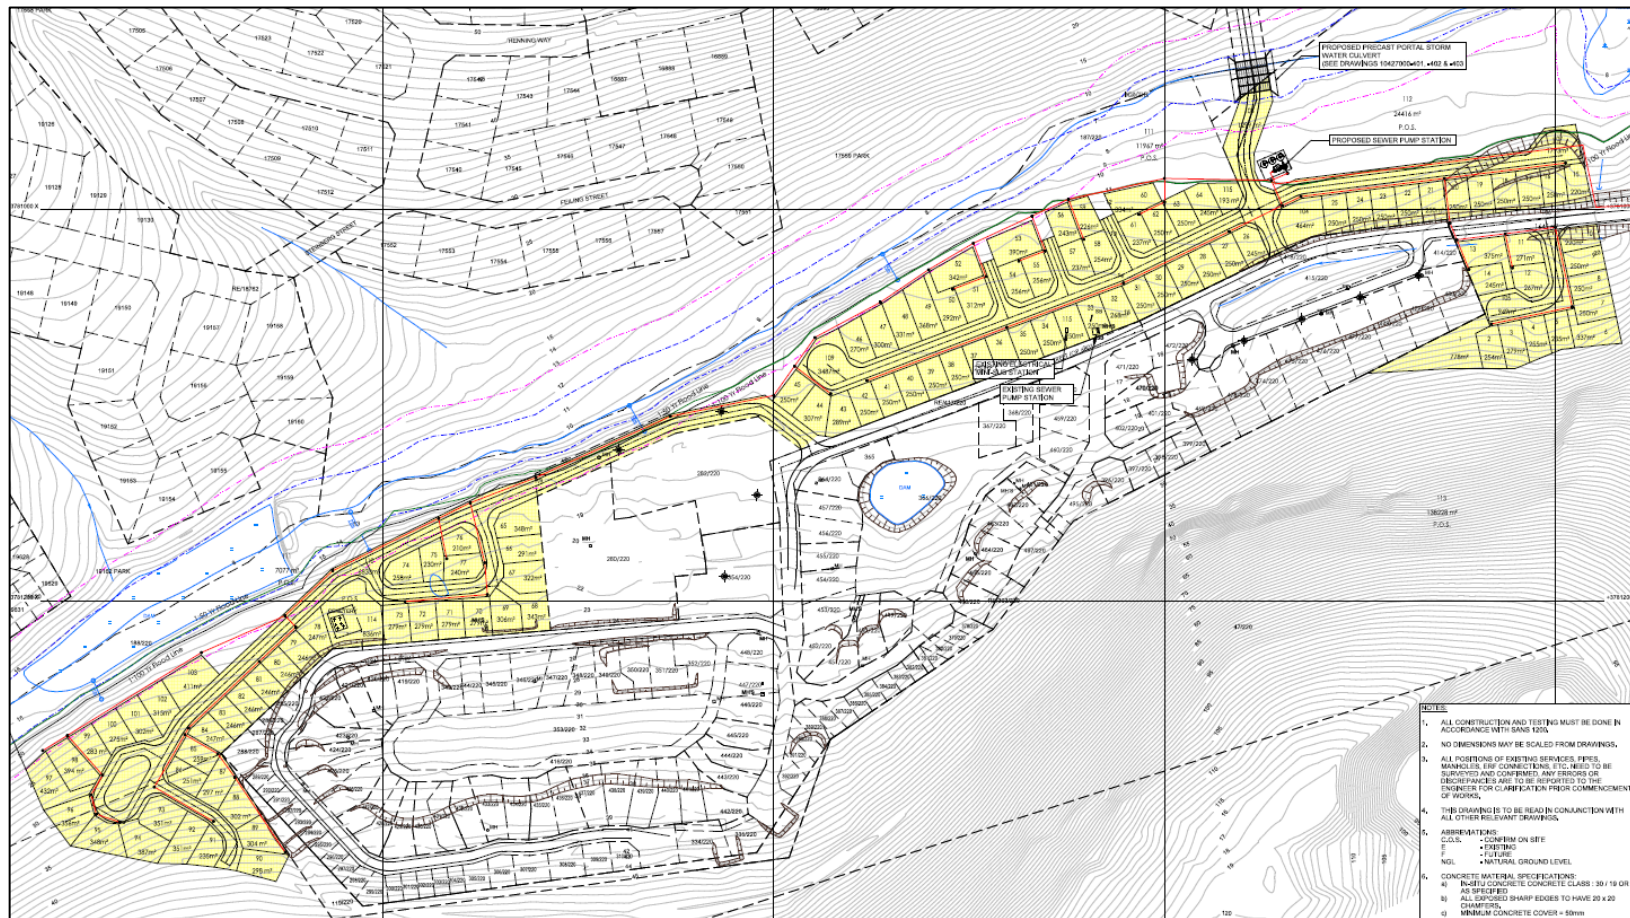
Figure 12: Proposed sewer network layout (Alternative B).
