GEOTECHNICAL REPORT

PROPOSED NEW FILLING STATION ON PORTION 4 OF FARM 135 GREAT BRAK, WESTERN CAPE

22 May 2017

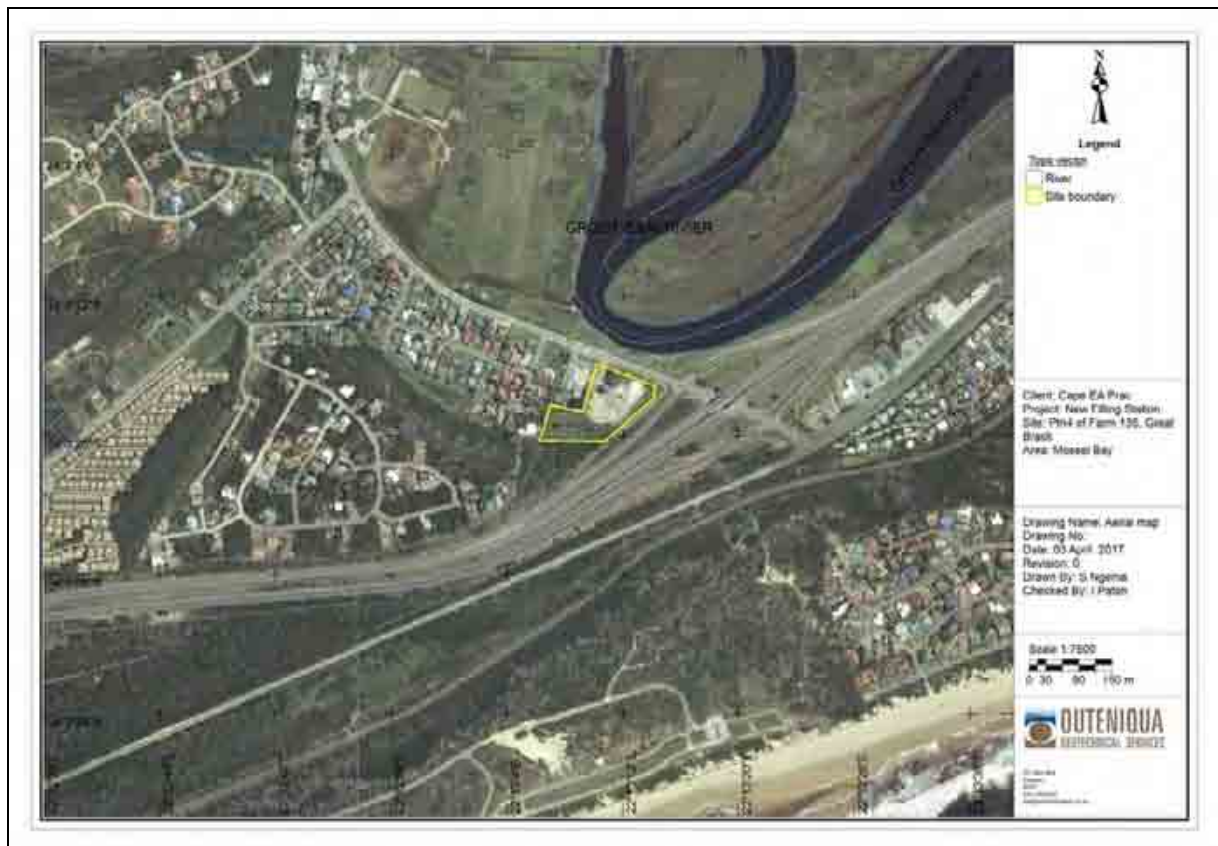
Figure 2: Aerial photo map

The site is located on the southern side of Great Brak, at the intersection of Long St and the N2 National Road (see **Figure 2**). The site is also located approximately 40m south of the Great Brak River. The topography on the site is very gently sloping to the north at a gradient of between 1:20 and 1:50, becoming slightly steeper towards the southwest.

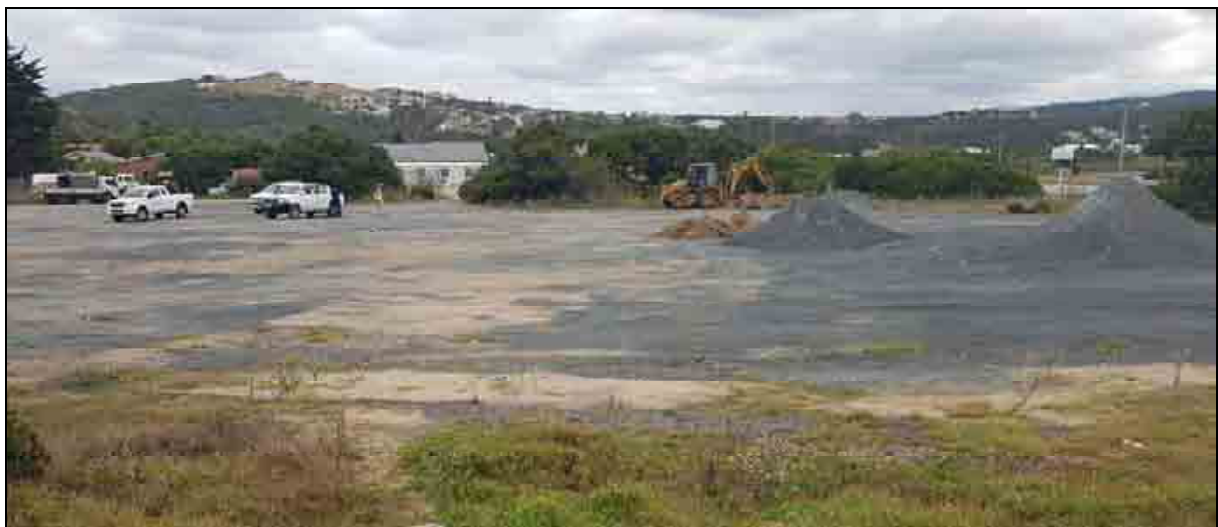
Figure 3: View to the north across the site

The climate of the area is temperate with an average annual rainfall of 450mm. The vegetation on the site has been completely transformed by historical activity on the site and is very sparse, mainly occurring around the edges of the site (see **Figure 3**).

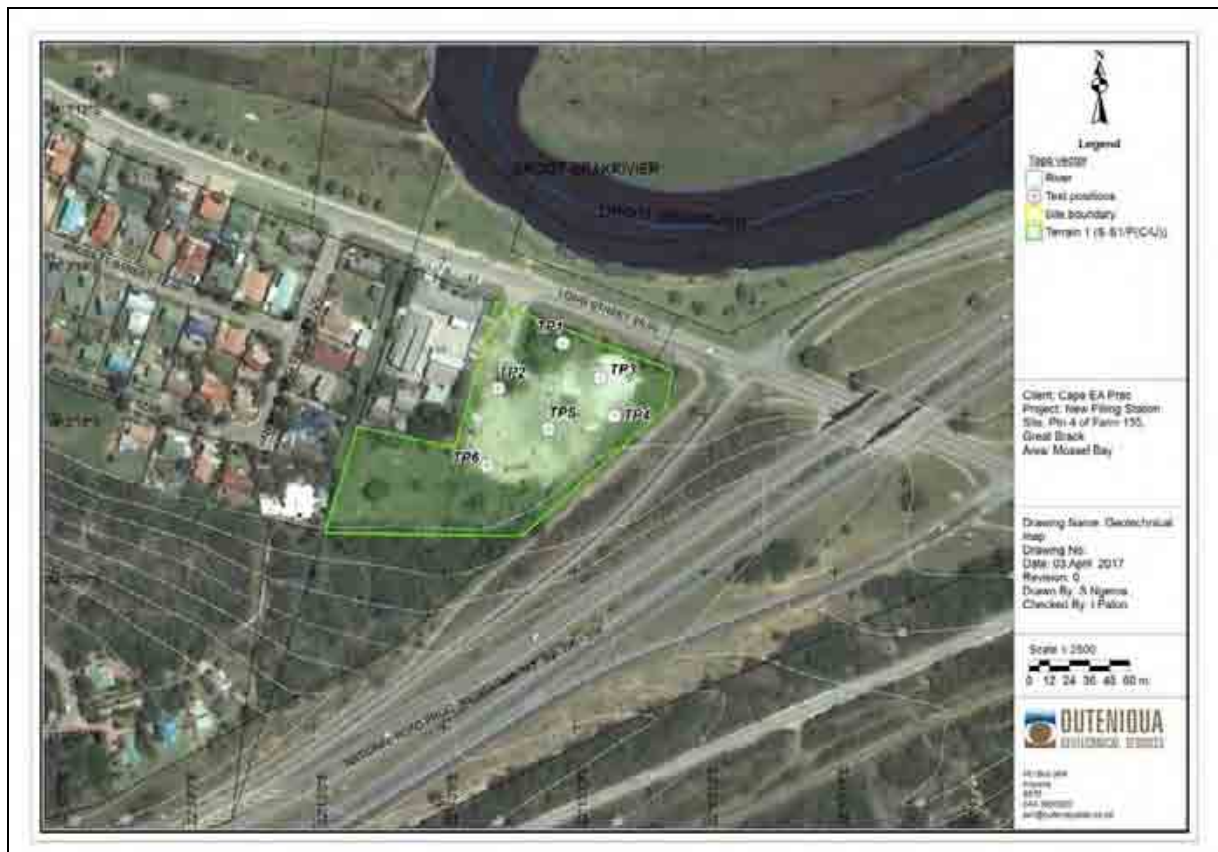
Figure 5: Geotechnical map of site indicating test positions and soil classification

Six test pits were excavated across the site to a max depth 3m, using a TLB/back-actor at the positions indicated in **Figure 5**. This enabled a study of the subsoil conditions (soil types, moisture levels, etc.) and depth to the water table. The soil profiles and photographs of the test pits are included in **Appendix 2** of this report. All test pits were excavated to below the water table, where the test pit was terminated due to collapsing sidewalls.

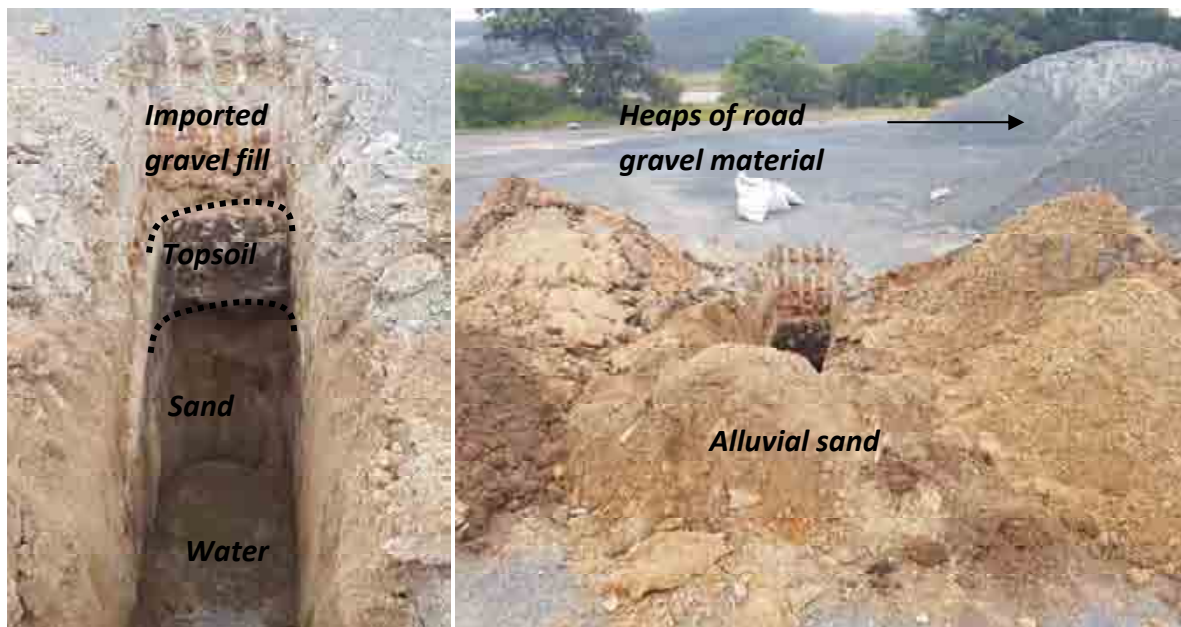
Figure 6: Typical test pit showing water table and soil types (TP5)

The natural soil profile underlying the site consists of a dark brown silty sand horizon (original topsoil), which is underlain by alluvial/estuarine sand (see **Figure 6**). The natural soil profile is overlain by one or more horizons of imported gravel & rubble material (uncontrolled fill), which covers most of the site, and increases in thickness to the south. The fill exposed in test pits was generally benign with no sign of contamination or significant deleterious materials, such as rubbish or organic matter, and is unlikely to pose a problem (see **Figure 7** – taken at TP6).

The soil moisture is generally moist and the permanent water table was encountered at a depth ranging between 2.2m and 2.8m. A summary of the test pit data is given in **Table 1**.

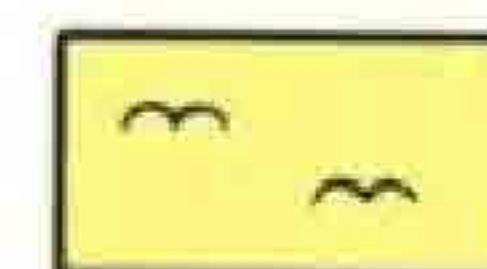
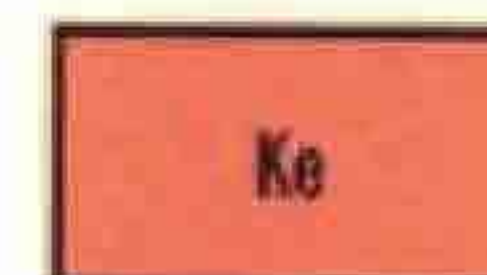
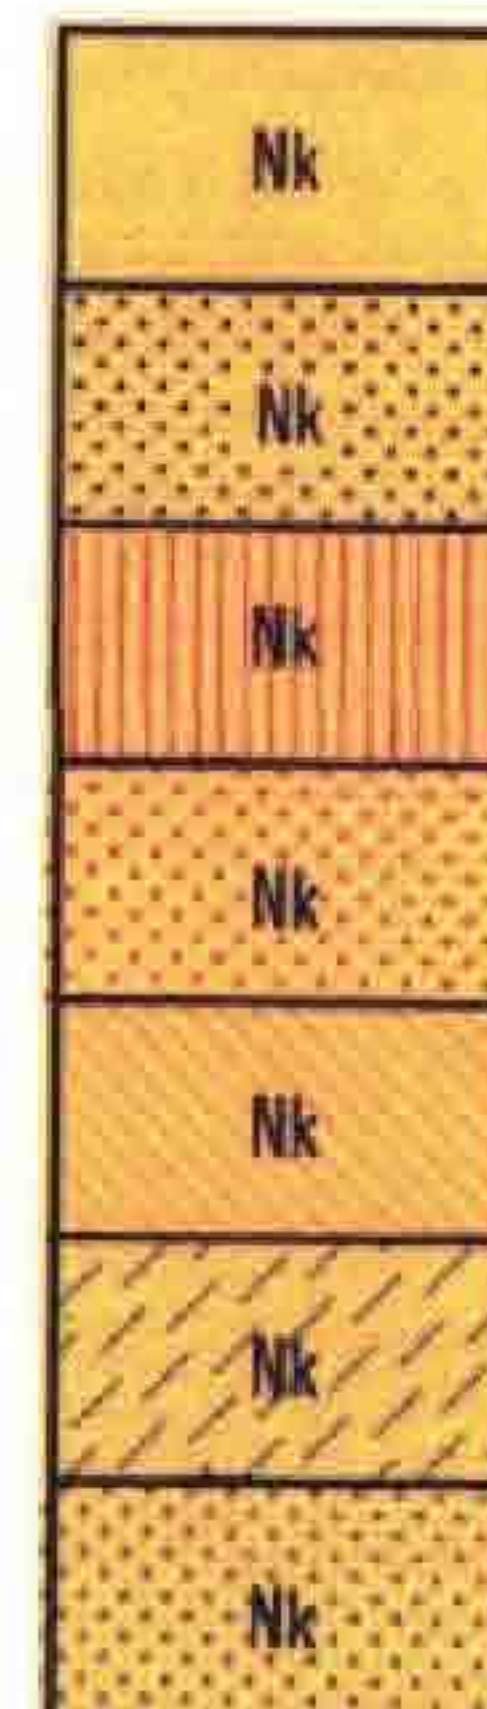
Alluvial valley deposits
Alluviale vallei-afsettings

Conglomerate, sandstone, siltstone, clay
Konglomeraat, sandsteen, sliestein, klei

Homtini	Phyllite, feldspathic grit, quartzite Filliet, veldspatiese grintsteen, kwartsiet
Victoria Bay	Feldspathic quartzite Veldspatiese kwartsiet
Soetkraal	Phyllite, schist, hornstone, quartzite Filliet, skis, horingsteen, kwartsiet
Skaapkop	Gritty quartzite, phyllite, schist Grintige kwartsiet, filliet, skis
Sandkraal	Quartz schist Kwartsskis
Saasveld	Andalusite schist, hornfels, mica schist Andalusietskis, horingfels, mikaskis
Silver River	Quartz schist Kwartsskis

Gneissic granite and
granodiorite, albitite
Gneisige graniet en
granodioriet, albitiet

Maalgaten and
related granites
Maalgaten-en
verwante graniete

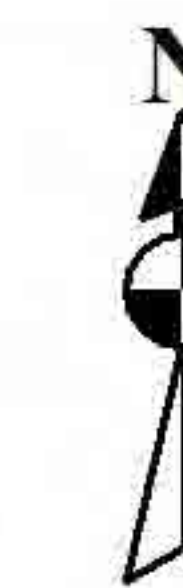
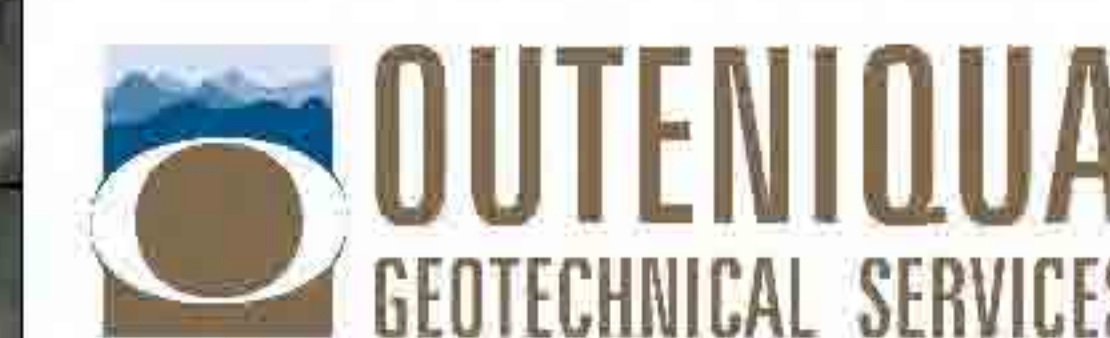
Drawing Name: Geotechnical
map
Drawing No:
Date: 03 April 2017
Revision: 0
Drawn By: S Ngema
Checked By: I Paton

- Topo vector
- River
 - Test positions
 - Site boundary
 - Terrain 1 (S-S1/P(C/U))
